Investigation of Cold Cathodes
for
Long Life CO₂ Waveguide Lasers

Annual Summary Report
for Contract N00014-79-C0312

U. Hochuli

November 1981

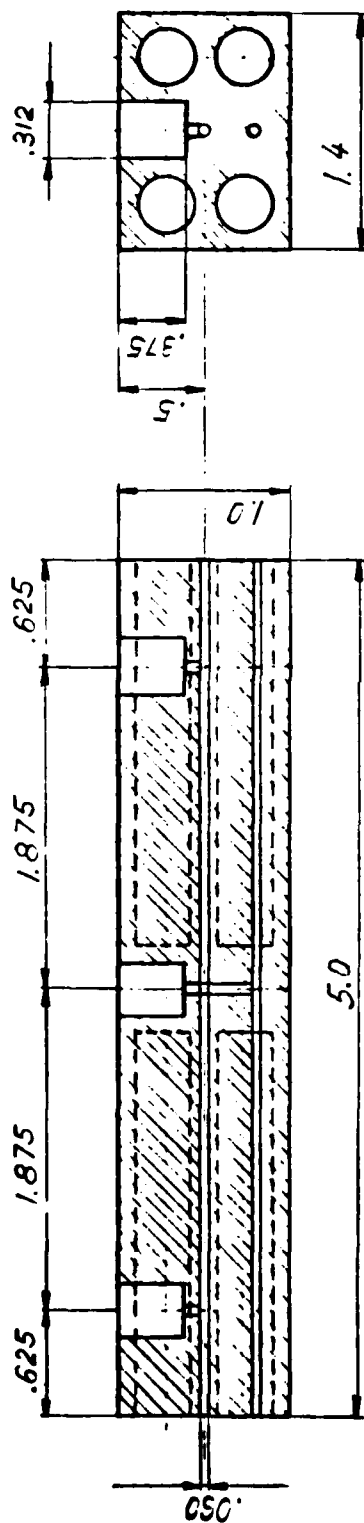
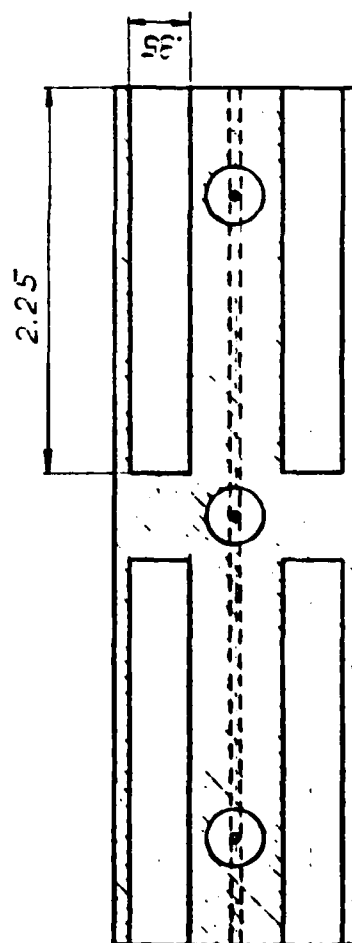
Fig. 1

Careful observations on the more than 50 different cathodes being tested indicate that semiconducting, sintered NiO is one of the better cathode materials. Such cathodes were actually used to generate the life test data with two of the BeO laser structures shown in Figure 1. Both of these lasers used three cathode type electrodes, one located 5/8" from each bore end and one near the bore center. Laser No 1 used both end electrodes as 2mA cathodes and the center electrode as the common 4mA anode. Laser No 2 worked with the end electrodes as 2mA anodes and used the center electrode as a common 4mA cathode. From the discharge tube results we know that the 4mA cathode is prone to considerably heavier sputtering than the 2mA cathode. Both lasers had indium "O" ring and indium film seals developed by us 11 years ago. All the seals on Laser No 1 were perfect but Laser No 2 had

a very small crack in the BeO body which was sealed with "Black Seal" liquid.
